## Dewar Shatters and Unexpectedly Projects Glass Outward

LL-2020-LLNL-1

LLNL-POST-801639

January 16, 2020

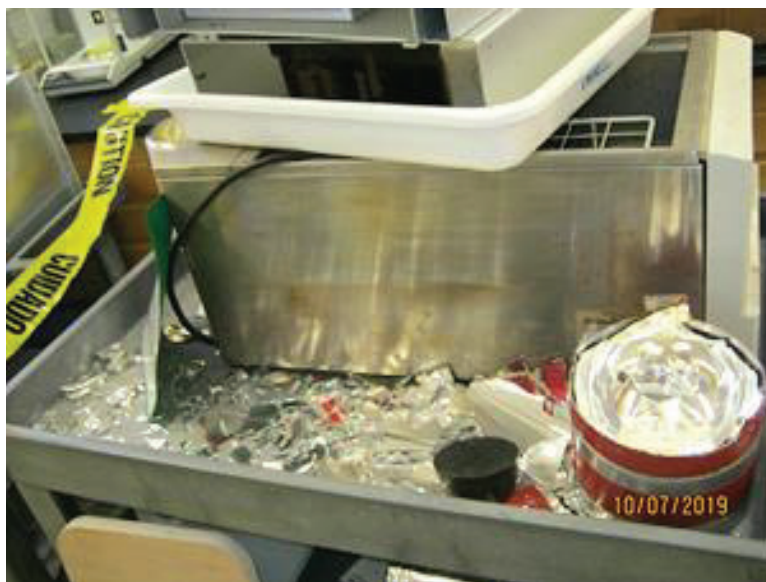
The internal and external surveys for D1 through D4 were completed without incident. Before surveying D5, the technician placed it into a plastic bag and used his gloved fingers to flake off most of the deteriorated tape on its exterior. The technician moved D-5 from the bag to the top shelf of the cart and then moved D1 through D4 to the bottom shelf of the cart. While bending over to do this, D-5 shattered and sent glass fragments in a projectile manner away from its location.

Glass fragments were observed on the technician's head and bare forearms. Radiological surveys did not detect any contamination on the technician. After transport to LLNL's Health Services Department, glass fragments were removed from his hair and eyelids.

- The potential for Dewar glass breakage was a recognized hazard. However, the working assumption was that the Dewar would implode, the glass fragments would drop into the bottom of the Dewar, and people next to the Dewar would not be injured by projectile glass fragments.

- Handling (over time and that day) may have weakened D5. This possibility was not communicated to the technician.
- Although deteriorated, the presence of the tape around D5 may have had some potential to provide some worker protection. Removal of this tape may have removed a mitigator against the outward projection of glass fragments in the event of breakage. Removal of this tape also may have made D5's glass unstable or more susceptible to handling damage/breakage.
- The decision not to wear a lab coat was in line with the governing procedures for survey work – it is assumed that survey work on equipment, even if made of glass, would not pose a physical hazard to the worker. However, not donning the lab coat before resuming the survey work increased the risk of injury.

1. Involve the custodians of the equipment receiving swipe/survey work during work planning to ensure that
  - the equipment conditions and potential hazards are identified and communicated to the personnel who may be affected,

- information about the potential need to dismantle/modify the equipment to ensure appropriate coverage is exchanged, and
  - appropriate limits and pause/hold points and re-start criteria are established.

2. If swipe/survey work or any of the supporting activities (e.g., handling, transport, disassembly, modification) needed to safely complete the task cannot be performed within the original limits in the work control document, stop work and ensure that all appropriate disciplines are involved in evaluating the task modification(s), their potential hazards/impacts, and the proposed barriers/mitigating actions.

3. Always wear the full complement of PPE specified for the task being performed.
